CONSTRUCTION INSPECTION AND DEMONSTRATION PROJECT FOR SEDIMENT MONITORING ON THE STILLWATER – ELLERSHOUSE SECTION OF THE HIGHWAY 101 TWINNING PROJECT, JULY – OCTOBER, 2002

R.S. Scott and D.H. Waller

Centre for Water Resources Studies
Faculty of Engineering
Dalhousie University, Halifax, Nova Scotia

CWRS Internal Report 03-07

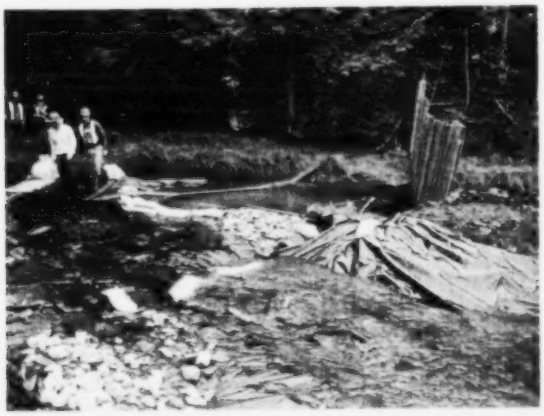
The area encompassing the diversion and culvert extension excavation was flooded during the September 11, 2002 rain event (refer to Figures 2 and 3). The alignment (perpendicular to the flow) and width of the sheet-piling barrier, installed at the upper end of the stream channel to divert flow into the diversion channel, played important roles in the failure of the diversion structure. The diversion channel wall nearest the sheet pile barrier was eroded during the event, permitting access of

flow to the dry area under construction. The sheet-piling was installed perpendicular to the direction of flow, with one wall of the diversion channel extending upstream of the piling barrier. This extension of the diversion channel wall was exposed to turbulent flow caused by the presence of the sheet-pile barrier during periods of high water, as was the case during the September 11-12 event (refer to Figure 4).

Figure 2. Installation of diversion trench for box culvert @ 13+700. Upper end. The sheet-piling was installed perpendicular to the direction of flow. As well, the channel wall extended upstream of the piling barrier. Doing so exposed the exterior side of the wall to water turbulence generated when the sandbag cofferdam was breached during the higher flows experienced during the September 11-12 event.

8) **Diversion Channels** - It is recommended that the design and sequencing of steps for the installation of diversion channels be reviewed. Three points in particular:

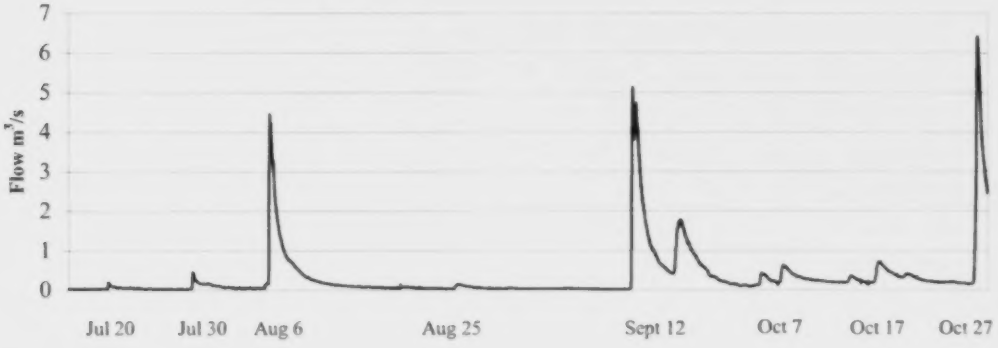
Figure 13. Bog Brook hydrograph for the period July 12 to October 28, 2002.
